TEST REPORT

Name : Actuator
Model/Type : SA005L
Manufacturer : EUNHA MACHINERY INDUSTRIAL Co., Ltd.

Test item	Test condition	Result
Vibration test	1. Test condition <ul style="list-style-type: none"> Frequency & Amplitude : 10 Hz → 57.55 Hz, 0.15 mm(level-peak) 57.55 Hz → 150 Hz, 2 g Test duration : Total 90 minutes (30 minutes for each X·Y·Z axis) The condition in the test : Operation 2. Acceptance criterion <ul style="list-style-type: none"> Mechanical failure should be reason for rejection. The specimen should operate under the condition mentioned in the sub-clause 3.2. 	PASS
Mechanical shock test	1. Test specification <ul style="list-style-type: none"> Acceleration & normal duration : 30 g, 18 ms The number of times : Total 18 times (3 times for each ±X·±Y·±Z axis) The condition in the test : Non-operation 2. Acceptance criterion <ul style="list-style-type: none"> Mechanical failure should be reason for rejection. The specimen should operate under the condition mentioned in the sub-clause 3.2. 	PASS

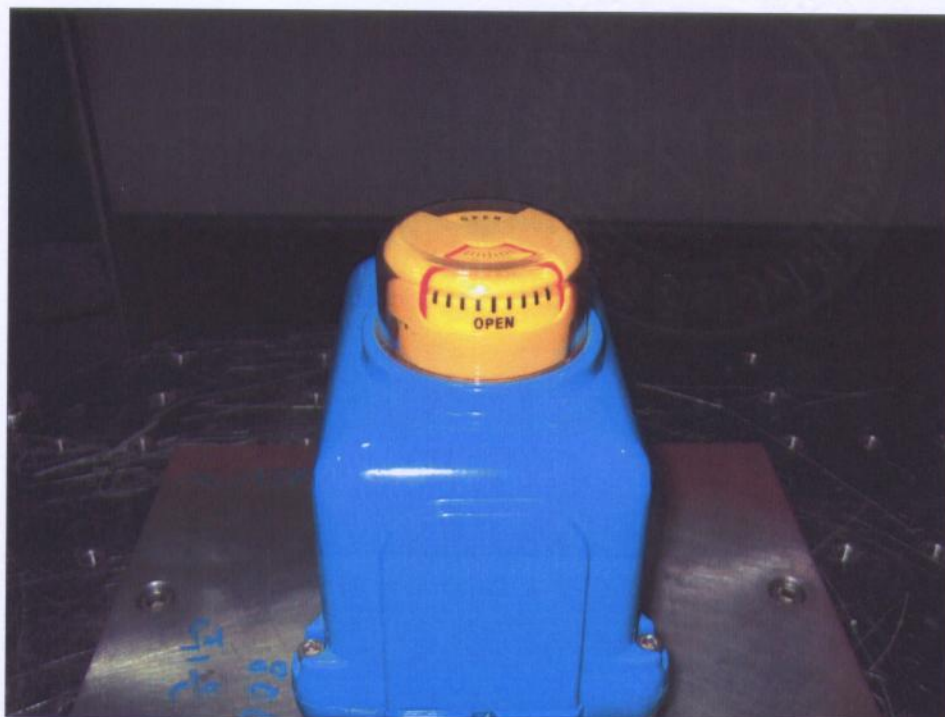
Figure 1. Specimen

Product	Model	The rated voltage	Test item	Sample size
Actuator	SA005L	AC 220 V	Vibration	1
			Mechanical shock

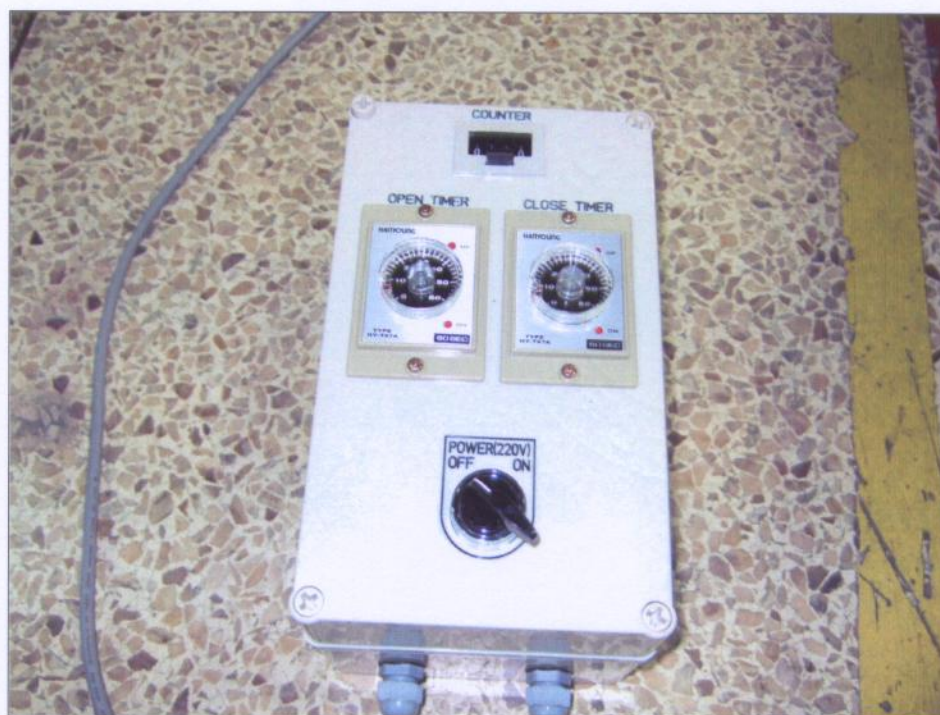
Figure 2. Controller

- There check that the operation current($4 \pm 0.2 \text{ mA} \sim 20 \pm 0.2 \text{ mA}$) normally measure with each 17 seconds rotating the shaft of the specimen under the rated voltage.
- There check that the shaft of the specimen rotate normally with each 17 seconds increasing the counter of the controller(REFER to the Figure 2) under the rated voltage.

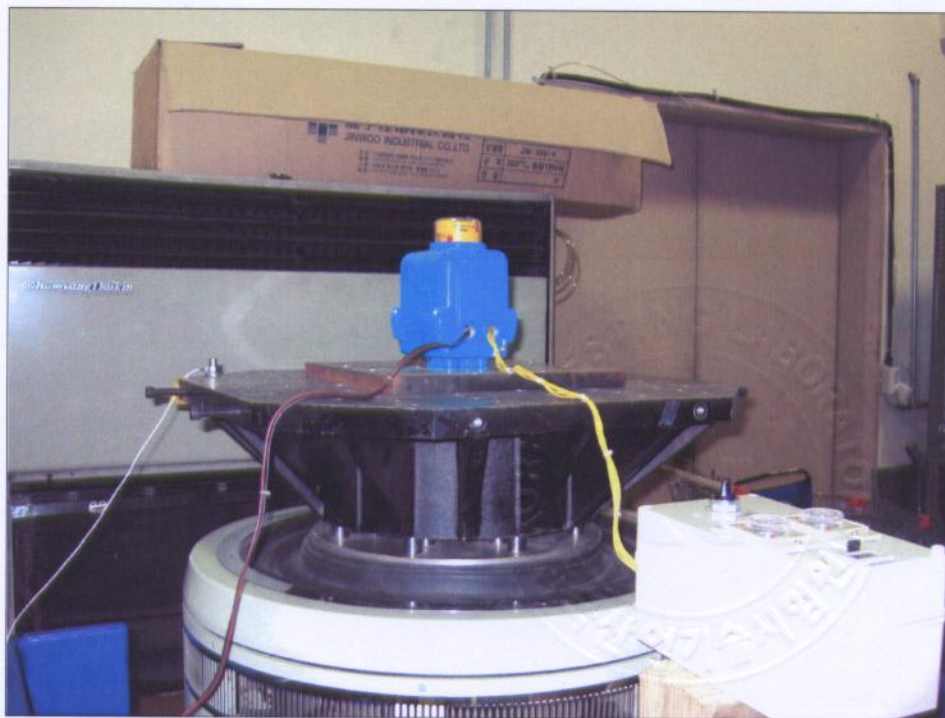
Figure 5. Test photo of Z axis vibration & mechanical shock test

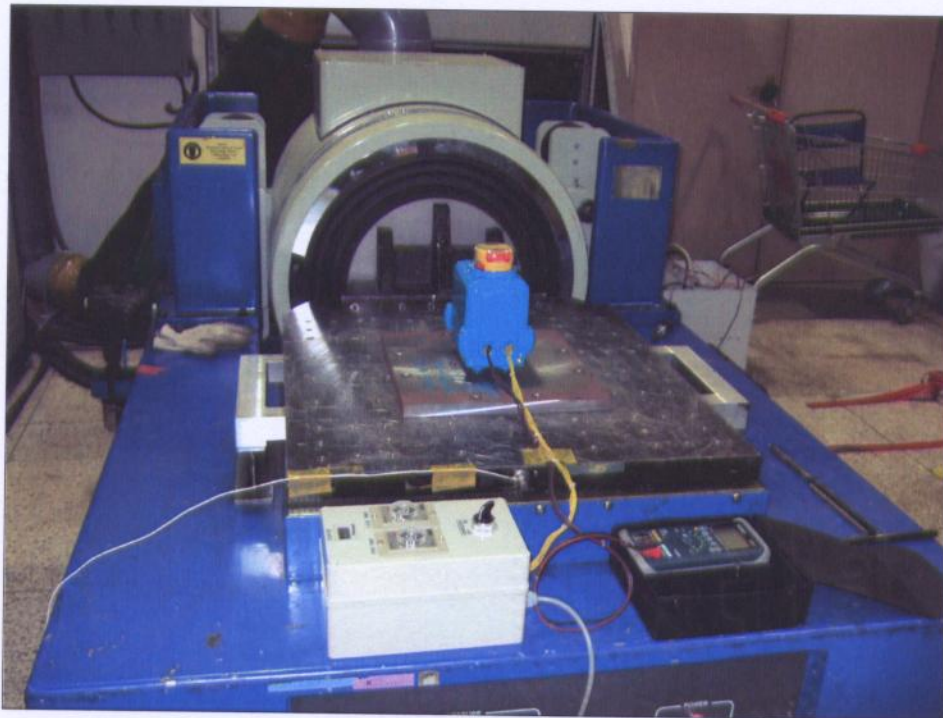
Figure 13. Test photo of Y axis vibration & mechanical shock test
